Methamphetamine FC Screening Assessment Report

Address inspected: 1-16 Rice Cr, Papakura, Auckland

Date of Inspection: 17/06/2020 Time: 8:30am

Test type: Field Composite (FC) Swab Screening Test - no. of sample kits = ONE				
Conclusion: Screening result was 0.42 for methamphetamine, indicating that no further testing is necessary. PROPERTY COMPLIES WITH STANDARDS NZ.				
Property description: single level residential house, separate garage.				
Sample Kit 1	Location	Photo	Result	
1 House	All rooms sampled.	Yes	0.42µg Field Composite Screening tests combine the level of the rooms tested.	
2				
3	See pics for exact locations.			
4	Total locations swabbed = 9	Yes

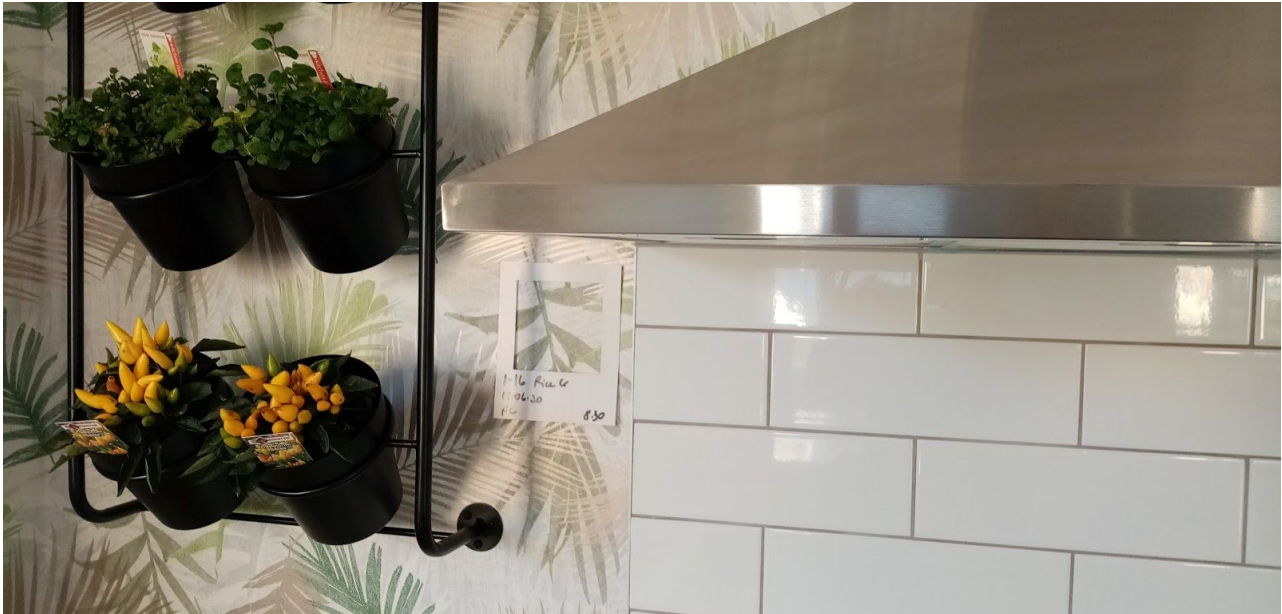
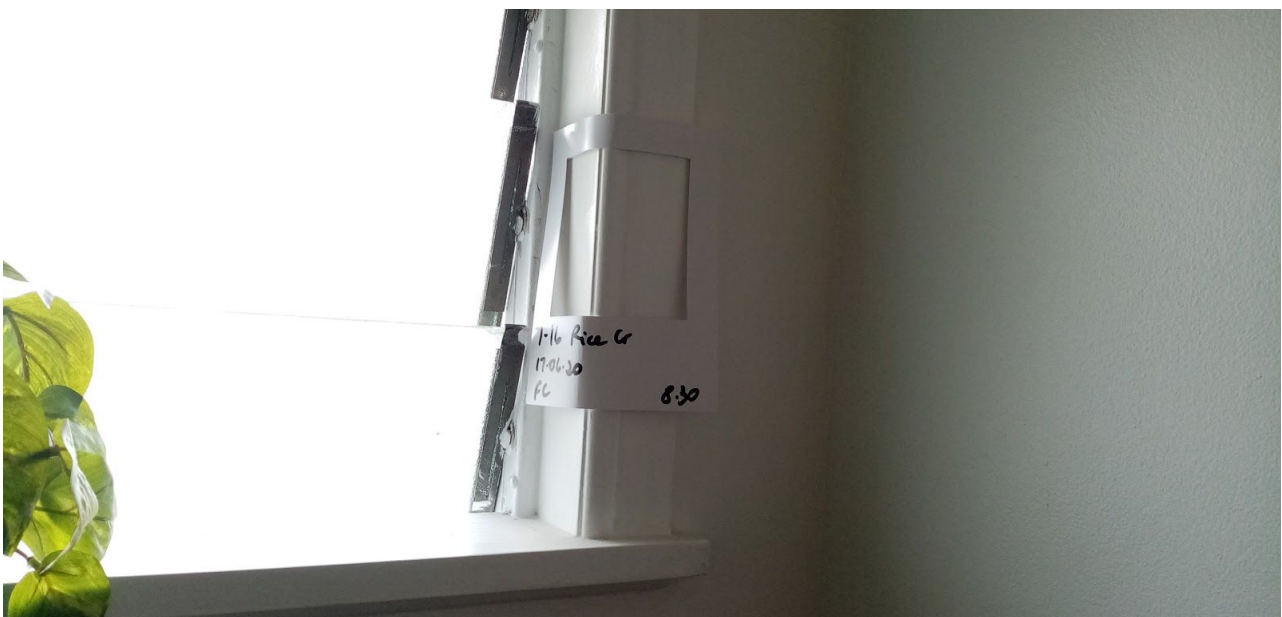
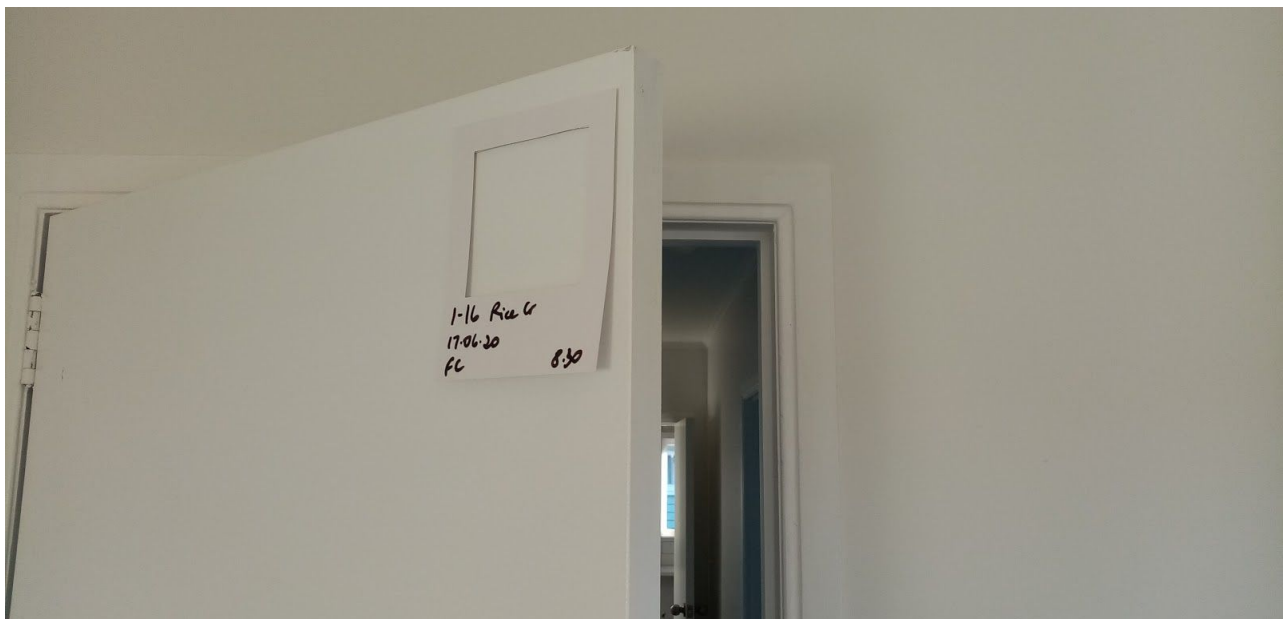
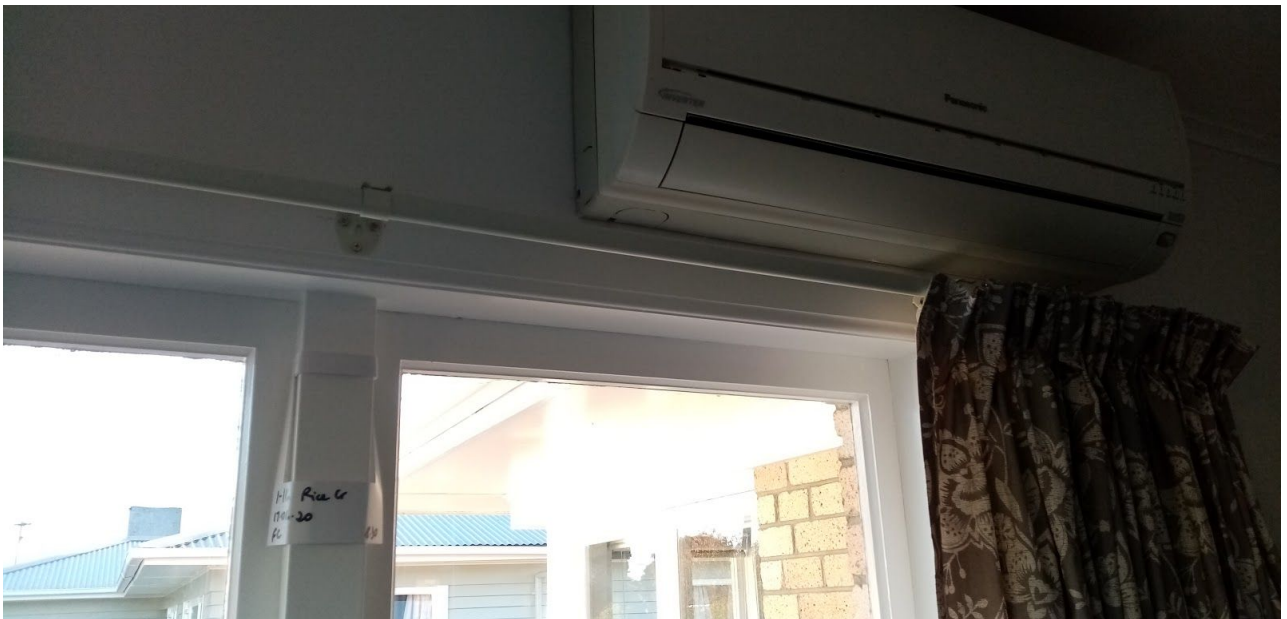
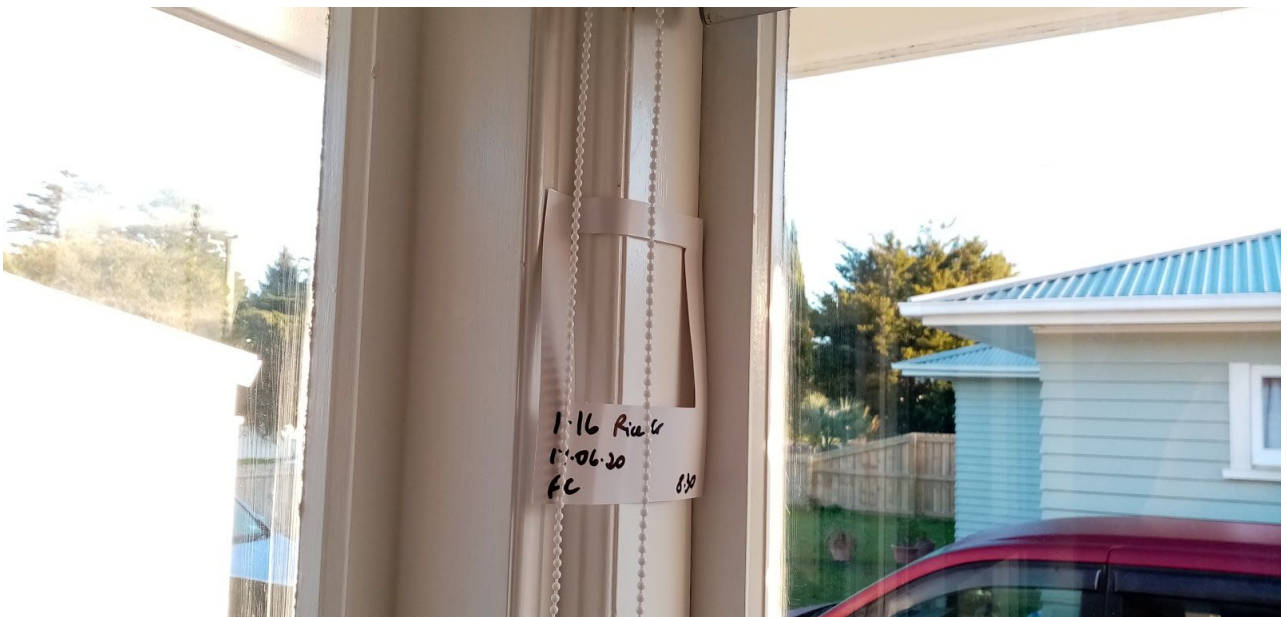
Pictures are for reference if further testing or other evaluation needed.

Photos and samples usually taken in a clockwise direction around house, starting in kitchen.
